ASSESSMENT OF STABILITY OF A REVITALIZED STREAM T12 IN ORLICKÉ ZÁHOŘÍ

Jana Marková, Petr Pelikán

MARKOVÁ JANA, PELIKÁN PETR: *Assessment of stability of a revitalized stream T12 in Orlické Záhory*. Acta Universitatis Agriculturae et Silviculturae Mendelianae Brunensis, 2013, LXI, No. 5, pp. 1321–1328

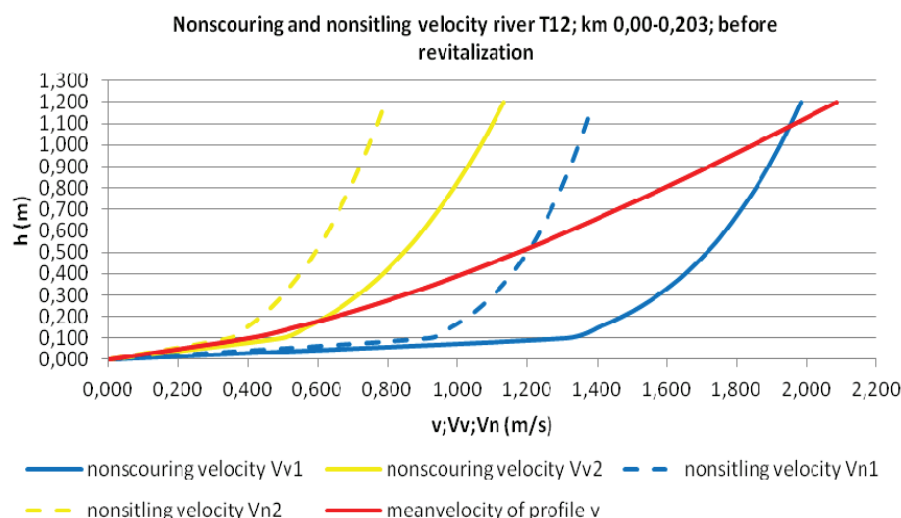
1: Orlické Záhoví-T12, non-scouring and non-sitling velocity km 0.00–0.203

Based on non-scouring velocity V_{v1} (d_c), the original bed is stable at a range of depths of 0.4 m–0.9 m, and the bed in the upper part is stable at a depth of 0.25–0.5 m. Based on non-scouring velocity V_{v2} , the bed is stable at much smaller discharges and depths of about 0.05–0.15 m. In the upper part (km 0.552–0.653), the bed is unstable even with the minimum depth of flow. The lower stability of the bed in the upper part is probably caused by a higher longitudinal slope when compared to lower parts.

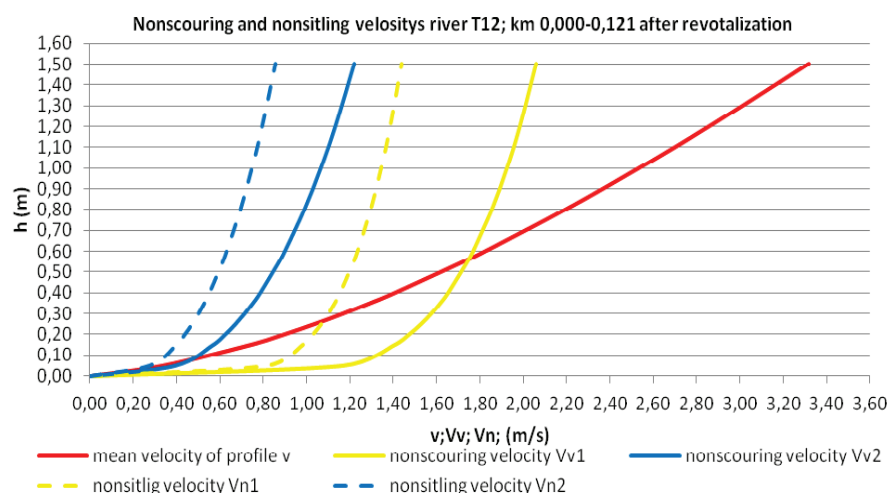
2: Orlické Záhory–T12, non-scouring and non-sitling velocity km 0.000–0.121

Based on V_{v1} , the bed after revitalization is stable at depths of flowing water of 0.25–0.55 m in the lower monitored part (km 0.0–0.121). In the part km 0.121–0.665 the bed is stable at a depth of 0.1–0.2 m. Based on V_{v2} , the bed after revitalization is unstable in the entire monitored section.
