DETERMINATION OF GRAIN SIZE AND RESISTANCE TO CORROSION OF STAINLESS STEEL WELDED PIPES

Abstract

The goal of testing in this paper was to compare samples. Samples were tested to discover problems by laboratory. As show figures 1, 2, 3 and 4, defects were occurred. The pipeline is for firefighting in Iraq's refinery. The water contains chloride according of water analysis.

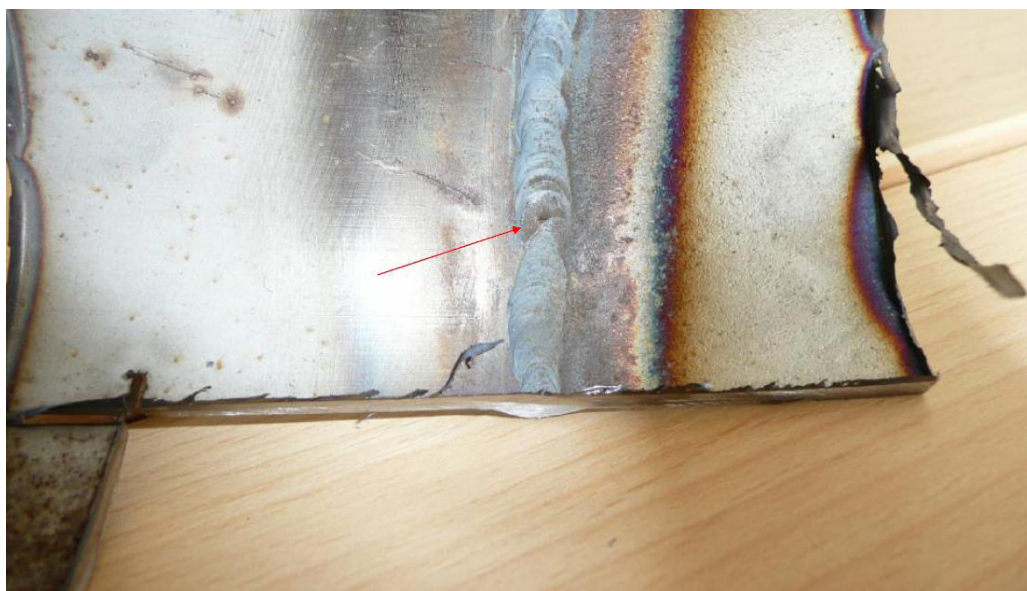
1: Leaker or segregation in root of weld

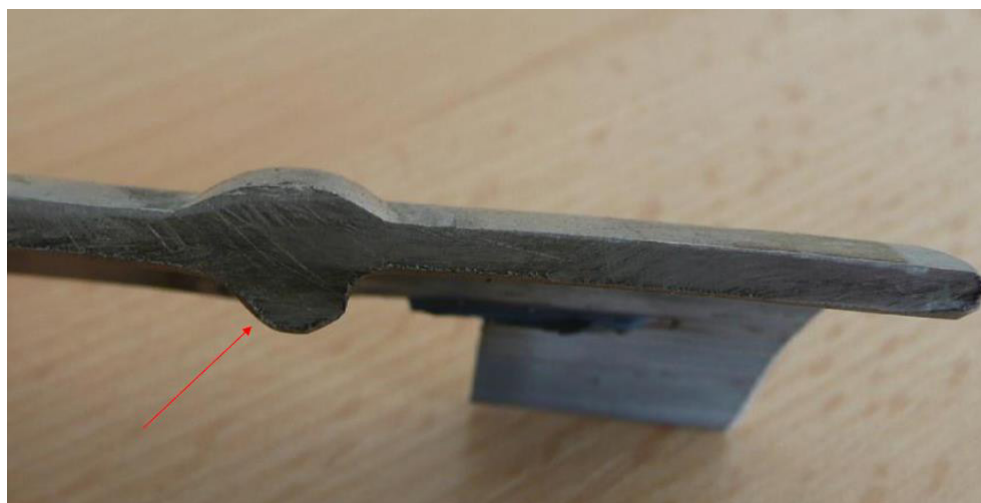
2: Internal protrusion in root of weld

All of the tested samples were investigated and tested of determination grain size and resistance to corrosion. According of testing and analysing the microstructures ssamples and those joint metals are not affected or damaged by an adhered particle of slag on the joint surface. The samples 1-J3 and 1-J5 are damaged along the grain boundary intercrystalline corrosion. The sample 1-elbow the surface was not detected and joint metal is not affected or damaged by slag inclusion. Internal protrusion in root of weld is still in the limit according of standards and strength is no touched.

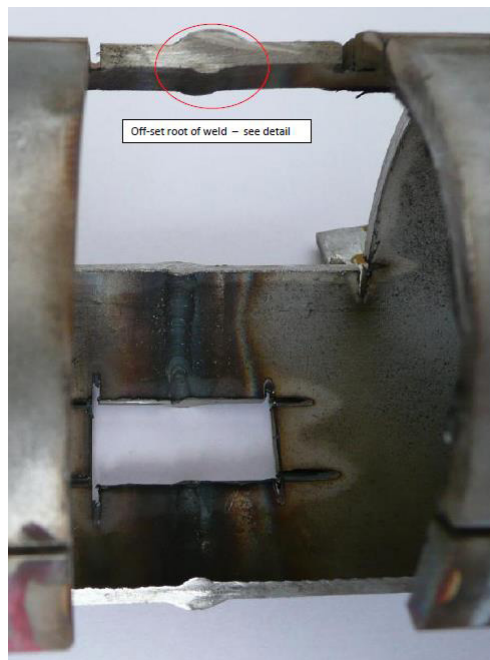
3: Off-set root of weld

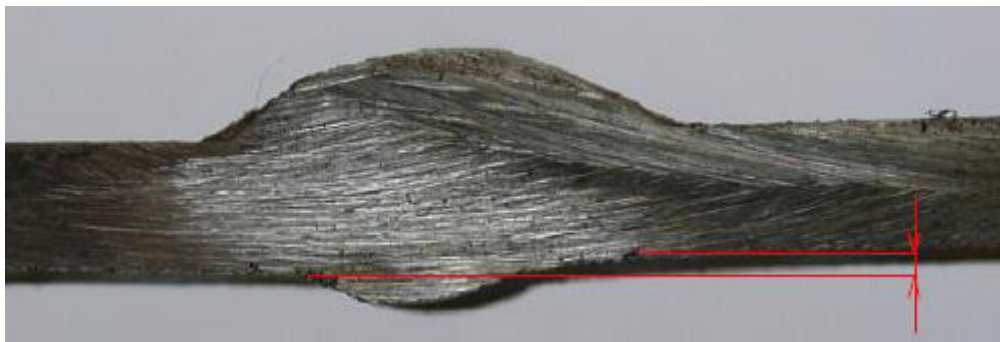
4: Detail Off-set root of weld

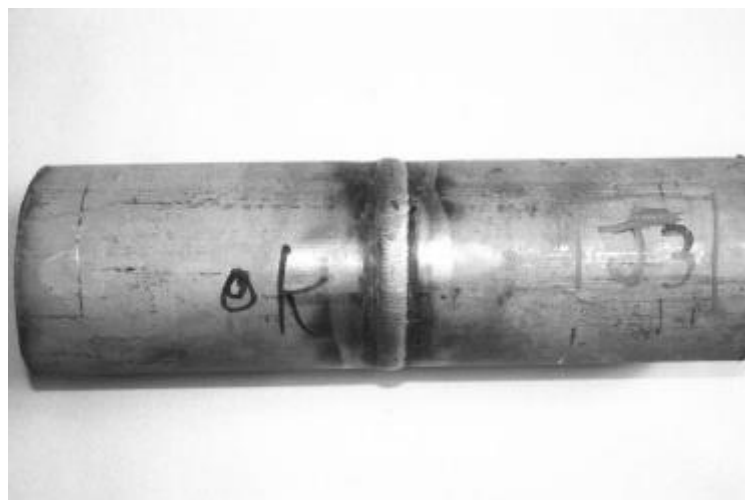
5: Tube sample J3

The tube with a joint indicated as J3, J5 and elbow, see Fig. 5 and 6. The sample of tube was handed over for analysis. On the weld joint and vicinity

were found deficiencies of surface, black spots (see Fig. 5, 6, 7 and 8) and plugged surface near weld joint (Fig. 9).

On this sample, i.e. the cut through the zone from Fig. 5 an adhered particle of slag was indicated on the joint surface. It is obvious in the Fig. 10, Fig. 11 and 13 there are parts of heat affected joint zones. Fig. 6 the damage of tube surface along the grain boundary is visible – intercrystalline corrosion which reaches the depth of 0.03 mm. The width of these zones is 2.0 mm on the left (reaches 0.3 mm to the joint) and 1.8 mm on the right side. The damage of surface TOO on the left side and the damage of the joint part in the etched specimen is in the Fig. 24.

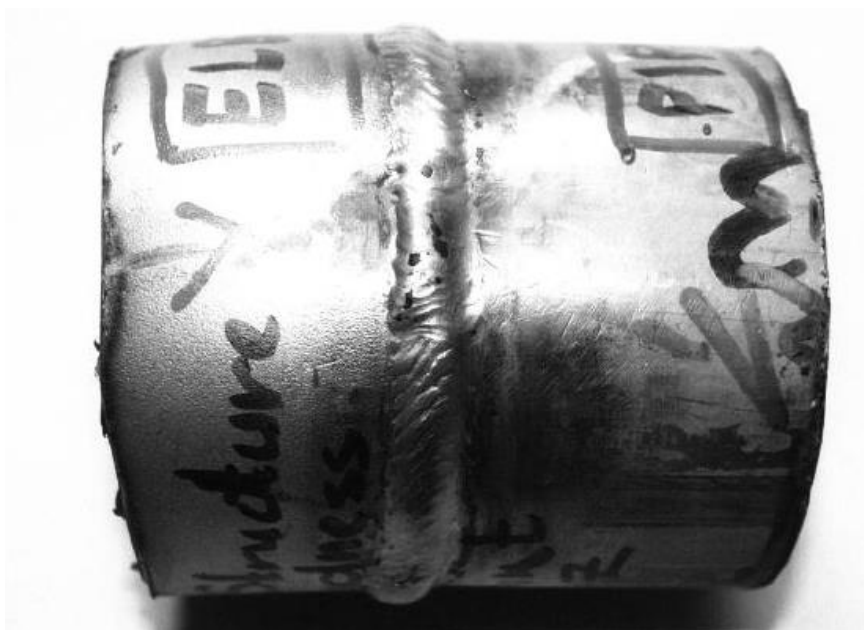
7: Elbow sample

The sample, the cut through zone Fig. 7 no damage of surface TOO was detected. The joint microstructure in this zone is in Fig. 23–28. The joint microstructure in this zone is in Fig. 17, 20 and 23. The base material has an austenitic structure with lines of δ -ferrite, grain size $G_{\max} = 3$, in the heat affected zone $G_{\max} = 4$. The structure of weld joint is austenitic with δ -ferrite. In the joint a slag inclusion of 0,9 mm was found out Fig. 28.

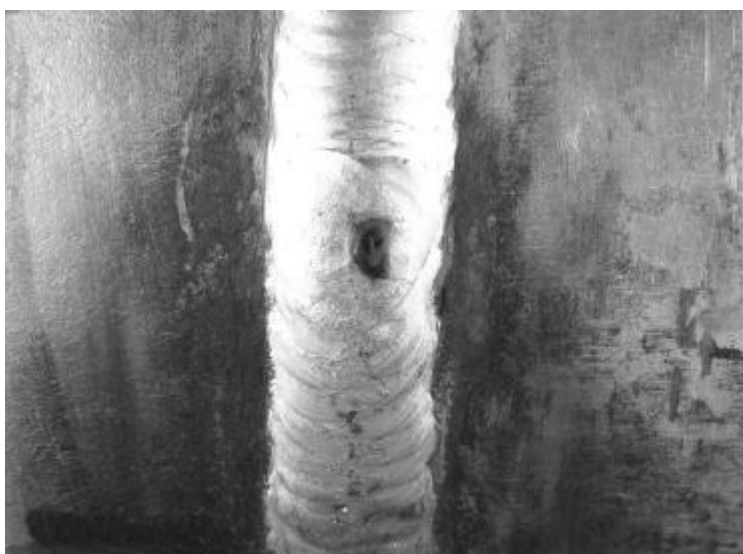
8: Deficiencies of surface and black spot sample 1 - JR3

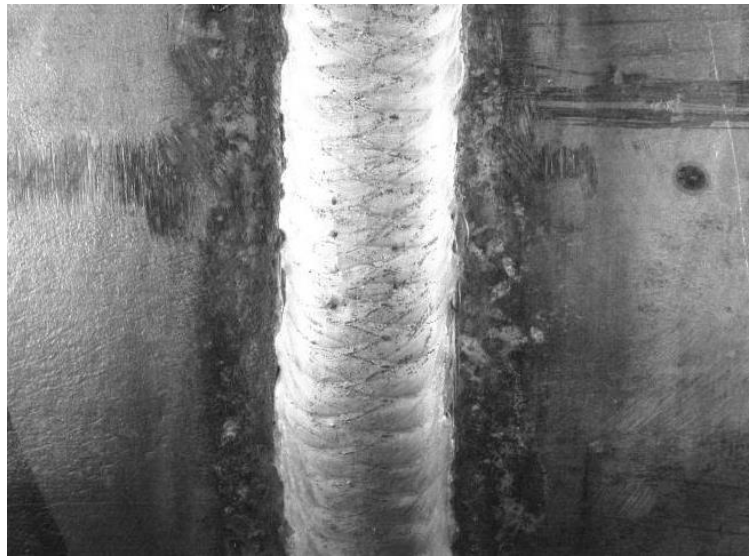
9: Plugged surface near weld joint

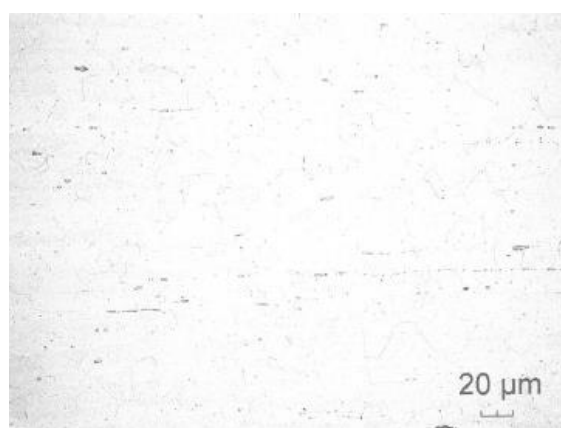
15: Sample 1-J3 400:1 Base material HNO_3 , HCl

The joint microstructure in this zone is in Fig. 15, 18 and 21. The base material has an austenitic structure with lines of δ -ferrite, grain size $G = 6-7$, in the heat affected zone $G_{\max} = 4$. The structure of weld joint is austenitic with δ -ferrite.

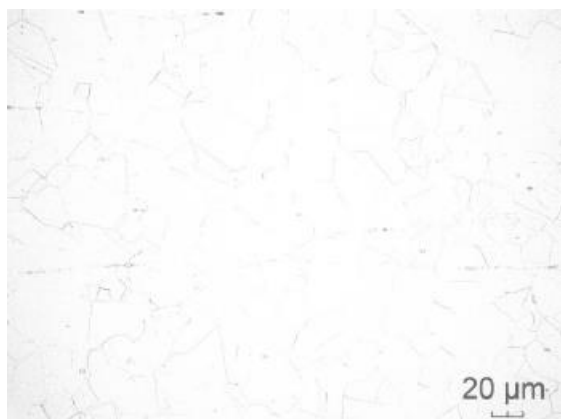
16: Sample 1-J5 400:1 Base material HNO_3 , HCl

zones is 2.0 mm (front end from the joint toe in the distance of 1,2 mm) on the left and 2,8 mm (front end from the joint toe in the distance of 1,8 mm). The damage of surface in the heat effected joint zone in the etched state is in the Fig. 25. The joint microstructure in this zone is in Fig. 14, 19 and 22. The base material has an austenitic structure with lines of δ -ferrite, grain size $G = 6-7$, in the heat affected zone $G_{\max} = 4$. The structure of weld joint is austenitic with δ -ferrite.
