THE SPREAD OF CORROSION IN CAST IRON AND ITS EFFECT ON THE LIFE CYCLE OF TRANSPORTATION VEHICLES

Tomáš Binar¹, Jiří Švarc¹, Petr Dostál², Michal Šustr², Jan Tippner³

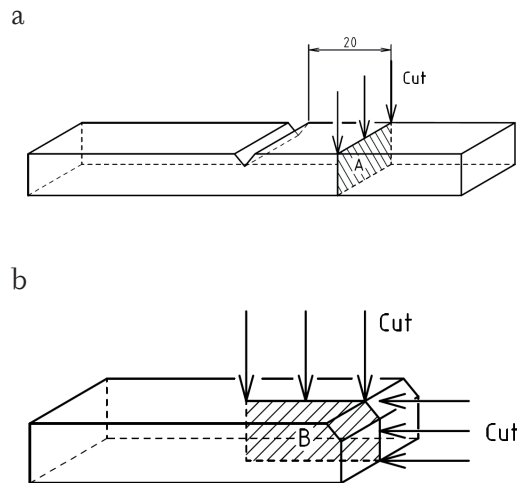
After the fixed exposure time, the sets of samples were prepared for metallographic analysis, the aim of which was to determine the depth of the corrosion on the surface of the sample (Fig. 1a) and in the notch; we can expect the greatest effect of the exposure to the corrosion on the formation and length of corrosion cracks, due to cross-sectional weakening in the notch compared to the cross section of the sample (Fig. 1b).

1: Corrosion attack depth from the surface/b Corrosion attack depth in the notch section

Evaluation of the local depth of corrosion on the surface of the sample measured at a 20 mm distance from the notch (Fig. 1a).

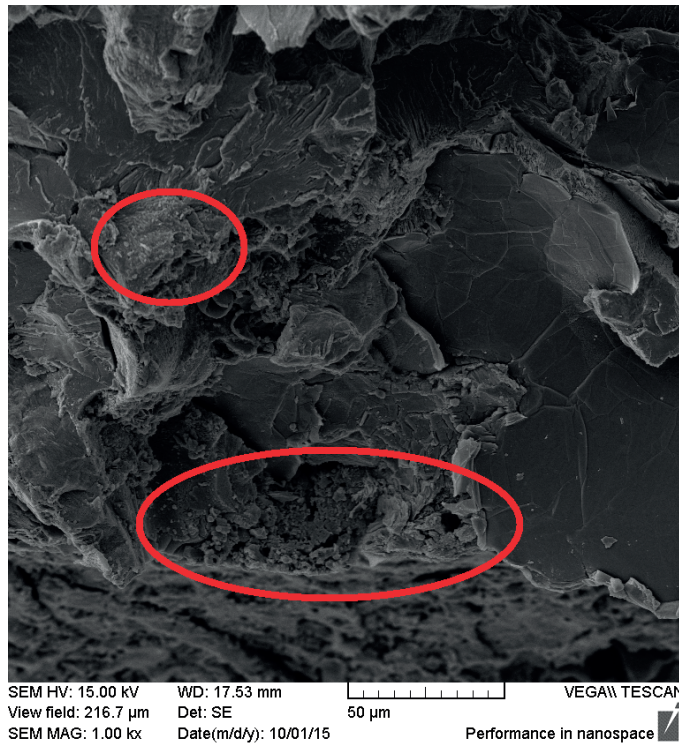
For the simulated corrosion tests with an exposure time of 432 hours, we analyzed the area around the notch (Fig. 2) and in the notch (Fig. 3) for the testing temperature of -80 °C. In these images there are noticeable areas A, B, C, D affected by corrosive degradation, which caused a significant reduction in the measured KCV values compared to other values of the determined characteristic.

2: Fractographic analysis Sample 1, 432 hours, area under the notch

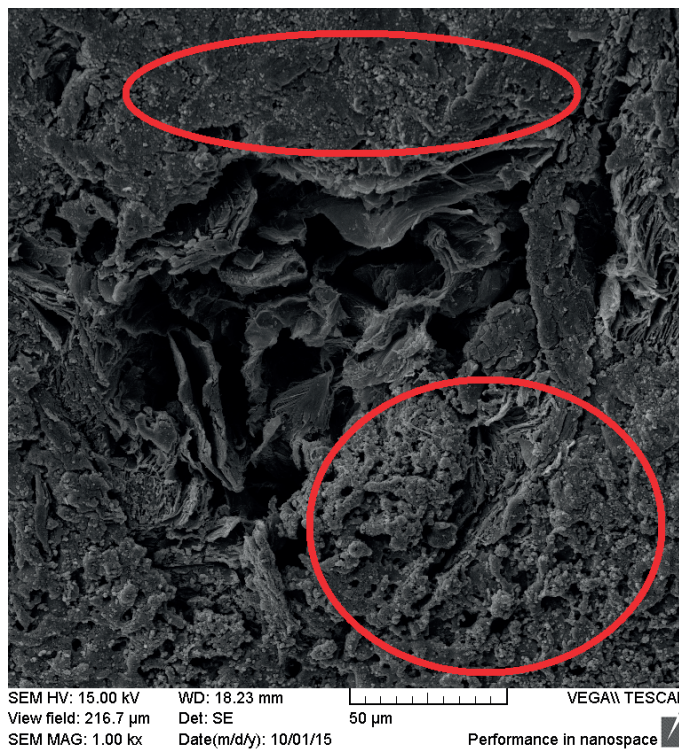
3: Fractographic analysis Sample 1, 432 hours, area in the notch

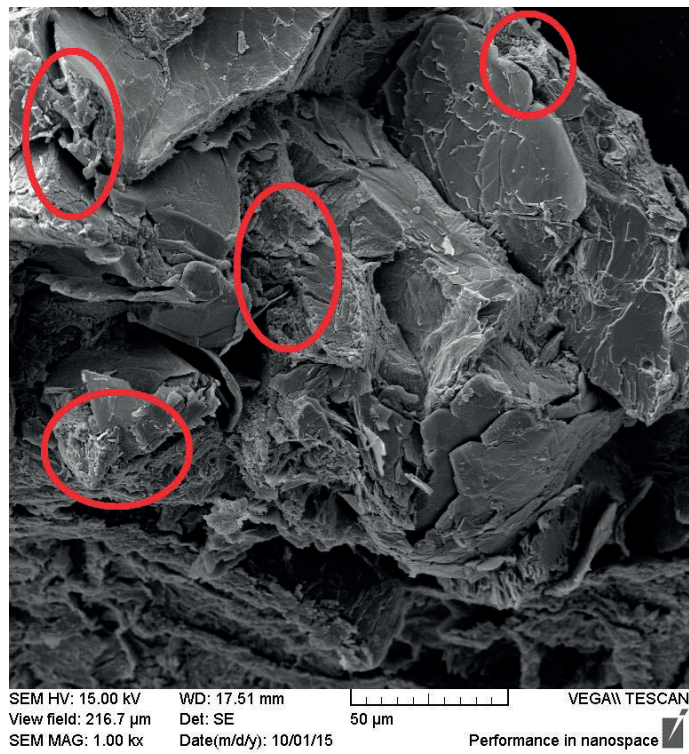
Analyzed areas (E, F, G, H) of the fracture surface around the notch (Fig. 4) and (I, J) in the notch (Fig. 5) in simulated corrosion tests with an exposure time of 648 hours, showed relatively extensive corrosion, causing a decrease in KCV values compared to the benchmark value.

4: Fractographic analysis Sample 2, 648 hours, area under the notch

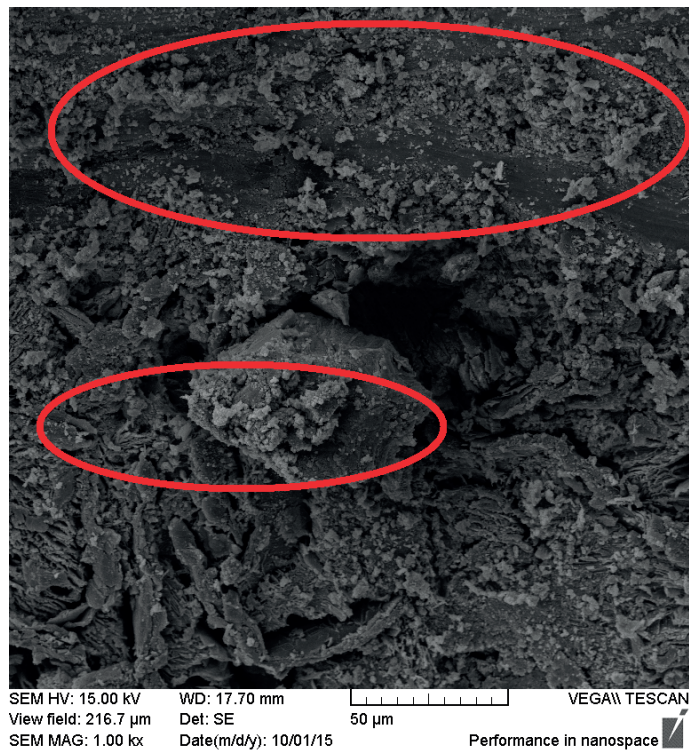
5: Fractographic analysis Sample 2, 648 hours, area in the notch

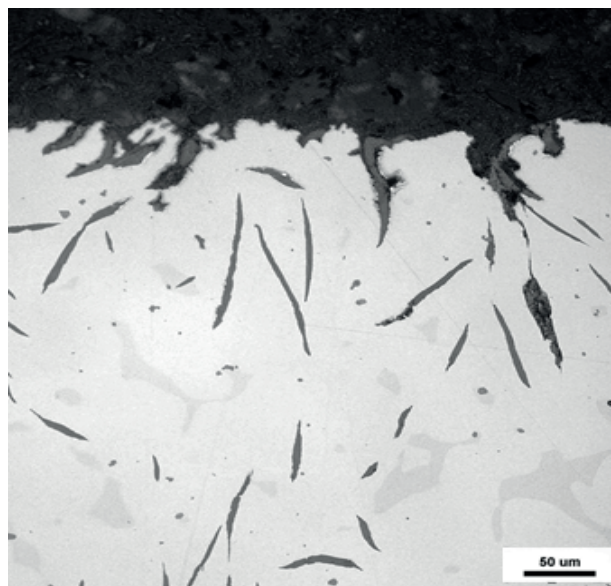
At the exposure time of 432 hours in the condensation chamber, we measured a mean depth of corrosion (length of corrosion cracks) from the surface in the range of 41 to 46 μm (Fig. 6 and Tab. III).

6: Metallography of the sample after the exposure time of 432 hours from the surface

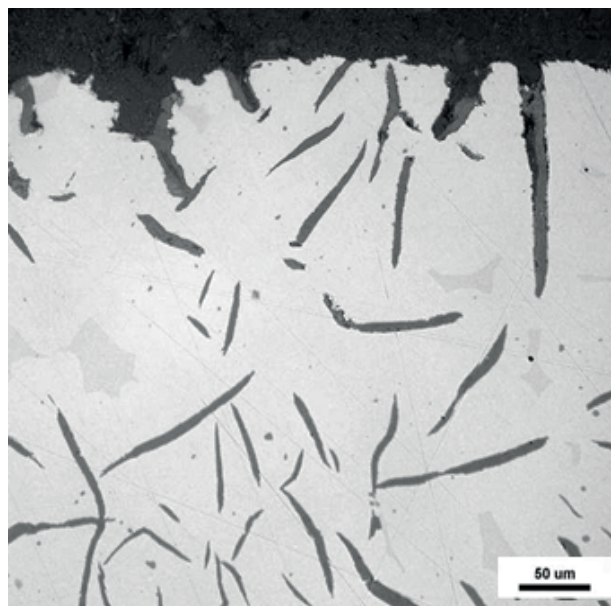
In test samples exposed to corrosive stress for a period of 648 hours, we measured the mean values of the depth of corrosion (length of corrosion cracks) from the surface in the range of 35 to 60 μm , and it was shown that the depth of corrosion cracks increases with the longer exposure time (Fig. 7 and Tab. III).

7: Metallography of the sample after the exposure time of 648 hours from the surface
