ENVIRONMENTAL ASPECTS OF KAISER S2 HARVESTER UTILIZATION IN MOUNTAIN TERRAINS

J. Slugeň, M. Jankovský

Abstract

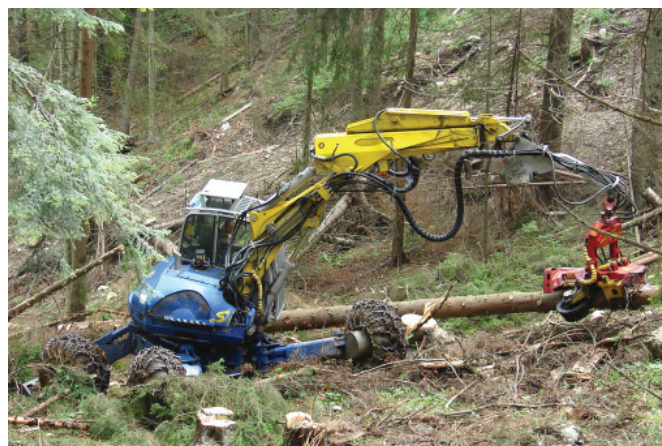
1: Harvester Kaiser S2 in operation

The measurements of stand soil damage and remaining stand were carried out in management-plan area Demánová in stand No. 819. This stand was damaged by a wind calamity and subsequently by insects. Species which was most damaged was spruce. Processing method of whole stem logging employed combined means of Kaiser S2 harvester and LKT 81T. The harvester (Fig. 1) processed the calamity and in unimpaired it carried out a secondary felling. The weight of the harvester was 9 980 kg, engine performance 116.9 kW, tires 600/50-22.5, harvester head WOODY 50 and reach of the hydraulic crane was 8.5 meters.

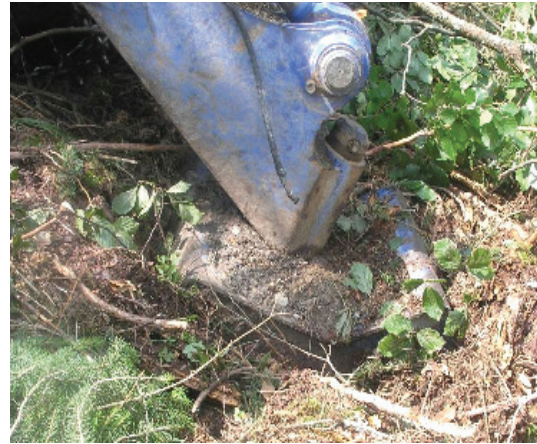
4: The supporting base of the machine

The harvester did not create visible tracks. Visible damage to the soil (Fig. 4) was noticed mainly where the supporting bases were deployed (Fig. 5). Besides soil compression their depth was also measured with 1 cm accuracy. The dimensions of the supporting bases were 80 × 60 × 20 cm.

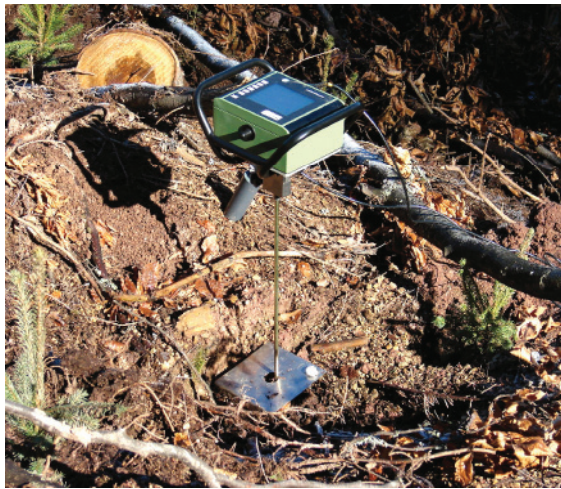
2: Measurement of soil compression

based on correlation between physico-mechanical characteristics of soil and its penetration resistance. In our case a „06.15 Penetrologer Set“ EIJKELKAMP equipment was used with a cone of 1 cm² and angle of 60° (Fig. 2). The device contains a ThetaProbe hygroscope, which records humidity in 6cm depth for individual measurements (Fig. 3), also used was a back stop, which lays horizontally on the soil and through it with an even speed the penetrometer is stuck into soil. Also used was a GPS antenna, depth sensor and an extension of the penetrometer rod.

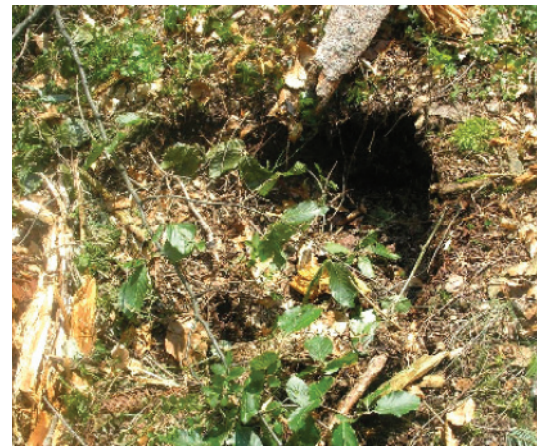
5: The mark left by the supporting base

The stand soil was damaged in form of holes by the supporting bases of the machine during works of Kaiser S2 harvester. Average depth of the holes was 15.8 cm. The damage, regarding its intensity, was classified as moderately damaged, which is described by 8–15 cm depth of damage. It is necessary to point

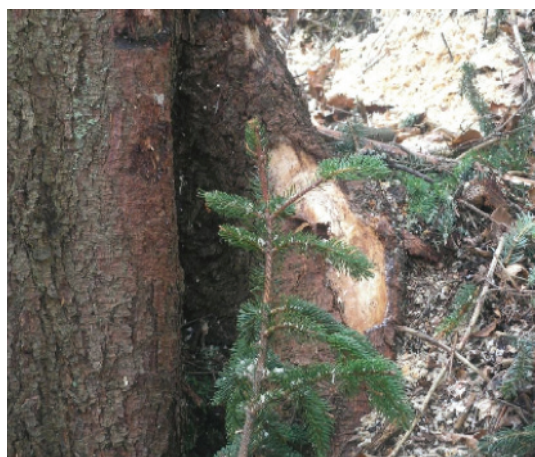
6: The most common location of damage on the trees

Most common was damage to the stump with root swelling and trunks above 1 m height (42.85%). Skinning of the trunk was caused by falling of the felled tree and in negligible rate by the hydraulic crane of the harvester.

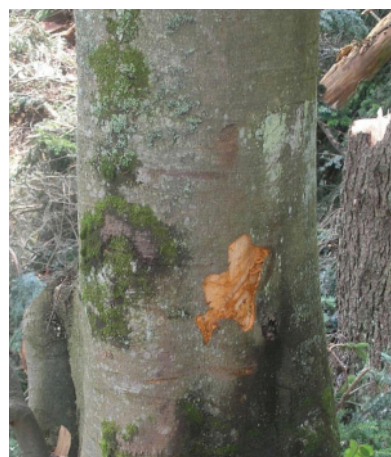
7: The most common location of damage on the trees

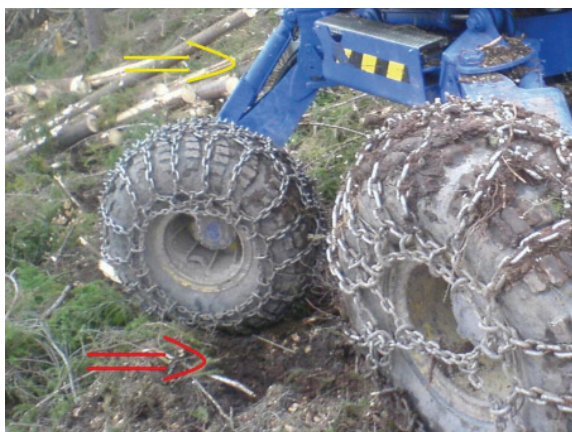
13: Steer angle of the wheel

Fig. 13 depicts alignment of the wheels (the yellow arrow) against the machine axis. The movement

of wheels turned towards the axis of the machine like this could be compared to movements of rotovators, which serve for soil preparation for forest regeneration. Fig. 14 and Fig. 13 (the red arrow) depicts local damage to the top level of the soil. The mark was not deep in all cases, thus we did not consider it to be damage. It reached depth of max. 5 cm. It is quite convenient as soil preparation for better seed germination from natural seeding.

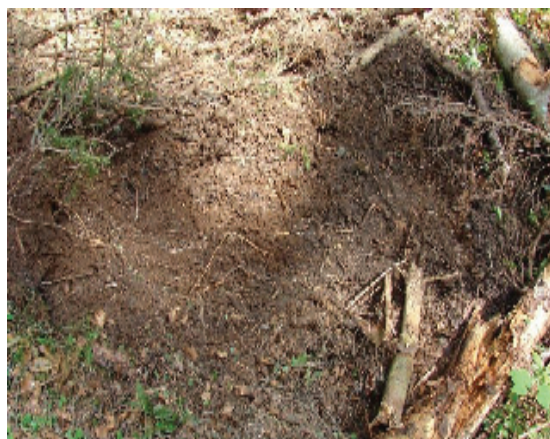
14: Local damage to the soil

Kaiser S2 works caused local damage to the top level of the soil with the wheels equipped with antiskid chains. Because the wheels are mounted on vertically and horizontally swinging arms, they were in different angles while moving through the stand.
