# POSSIBILITIES OF MONITORING THE TECHNICAL CONDITION OF THE COMBUSTION ENGINE WITH STARTER LOAD CURRENT

JUKL MICHAL, POLCAR ADAM, ČUPERA JIŘÍ. 2014. Possibilities of Monitoring the Technical Condition of the Combustion Engine with Starter Load Current. *Acta Universitatis Agriculturae et Silviculturae Mendelianae Brunensis*, 62(5): 961–969.

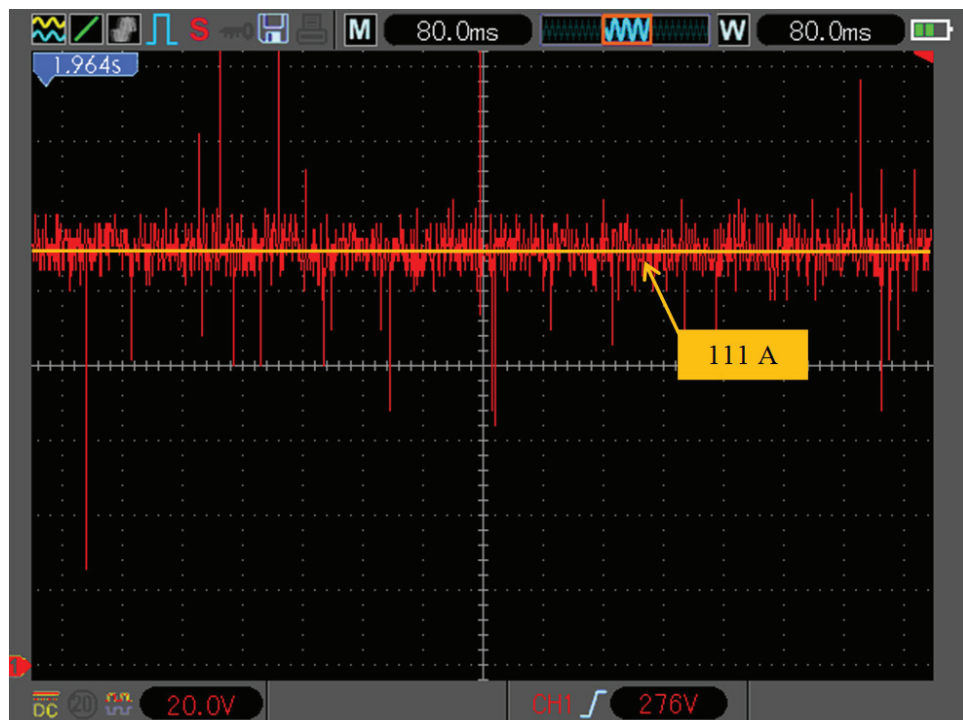
6: The waveform of load current during simulation of leaks of all cylinders (spark plugs removed from the engine)

As is evident from Fig. 6, the starting current slightly decreased. The mean value of current was 124.5 A. The load current decreased about 4% (compared with reference values of current). When all spark plugs were removed from the engine, the mean load current decreased to value 111 A, in other words about 15% (see Fig. 7).

As also Fig. 7 shown, simultaneously with a decrease of current, which is needed for a spin of the engine, the higher frequency of current is recorded. Due to it is not possible to distinguish of individual current peaks among cylinders. Better resolution could be achieved by setting of time base (when all spark plugs are removed, crankshaft has

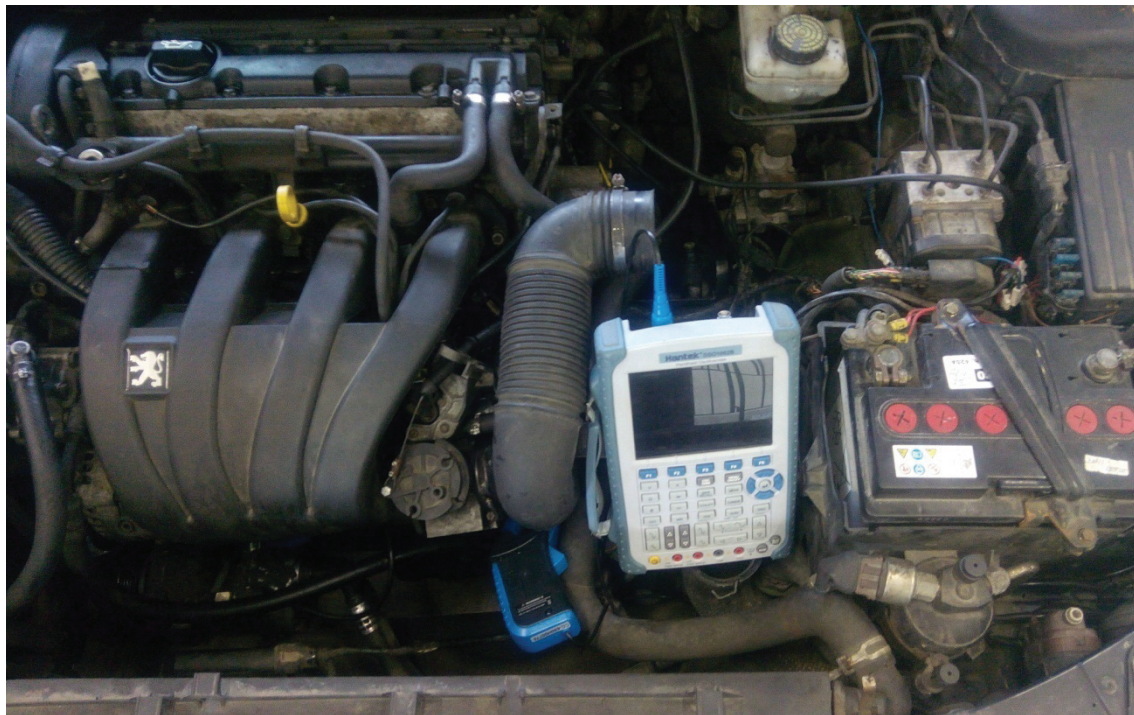
7: Peugeot engine 1.8i 16V LFY XUJP4

To verify the preceding contention measurements were taken at another engine. It is a petrol engine Peugeot 1.8 16V LFY XUJP4. For measurement were used the same equipment as in the previous case – see Fig. 8.

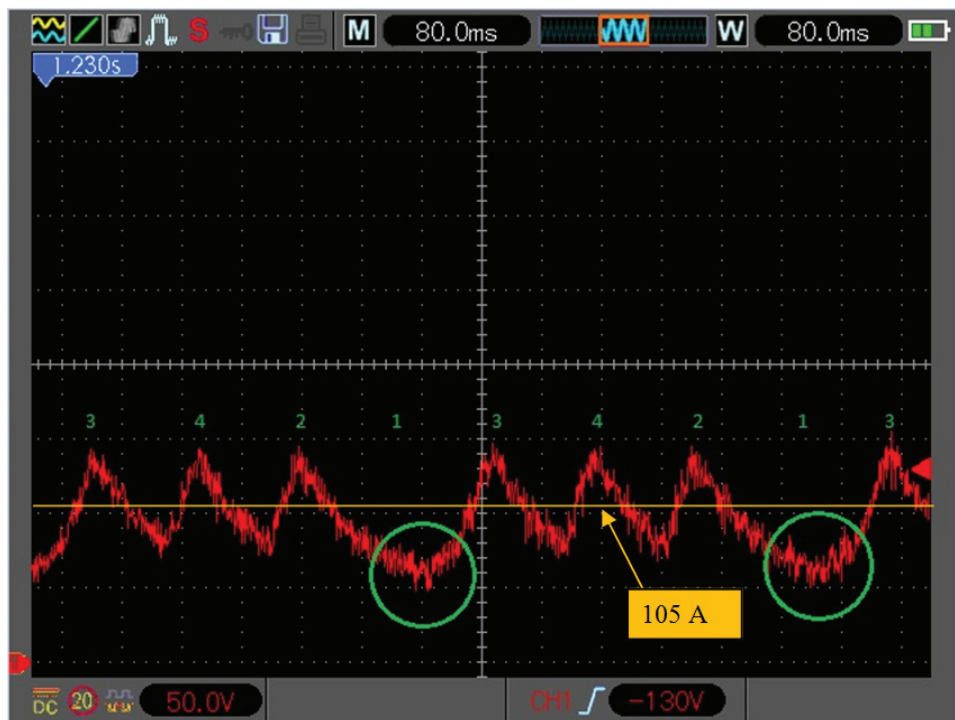
9: Waveform of load current at leak simulation of the first cylinder – Peugeot engine

Current clamp connecting and the oscilloscope settings is identical to the previous case. Even in this case, measurements were made without a simulation of leakage, then with the creation of leakage (disassembled spark plug).

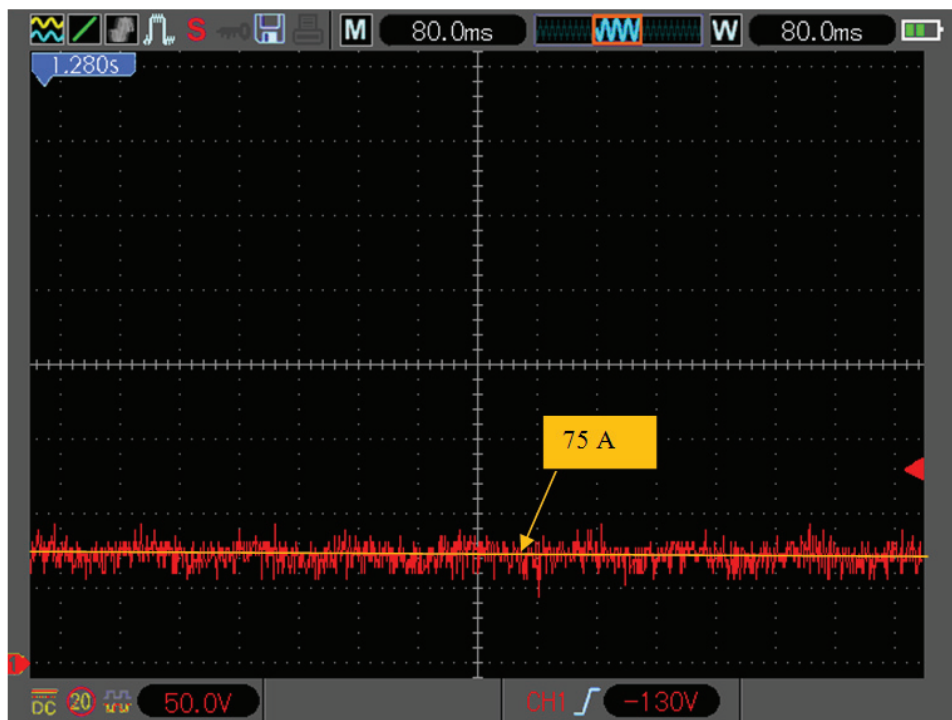
10: Waveform of load current without sparkplugs
